## ACCREDITED LABORATORY TEST REPORT

### 12591/E/24

| TEST OBJECT | Station post insulator | |
| TYPE SPECIFICATION | TR-291 | |

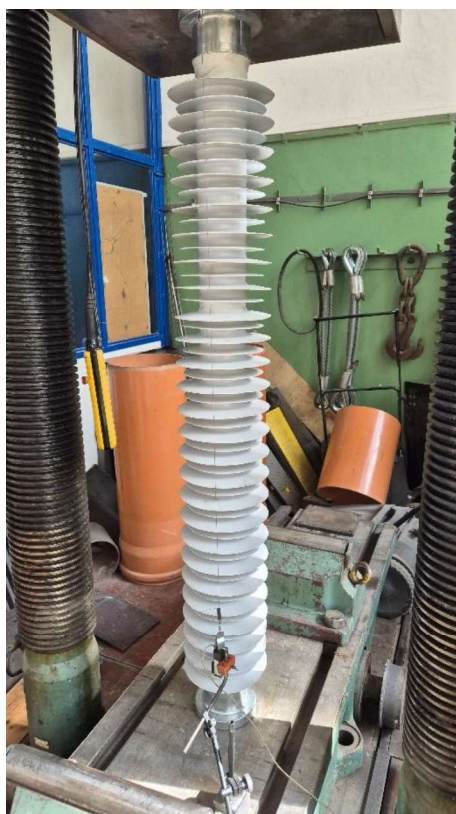
**Photo 1** – Characteristic arrangement of the compression test

| Sample No. | Maximum reached load [kN] | Change of the sample's length after applied load 444,8 kN [mm] | Test result |
|---|---|---|---|
| 4 | 444,8 | 0,6 | No failure, No cracks were observed after dye penetration test |

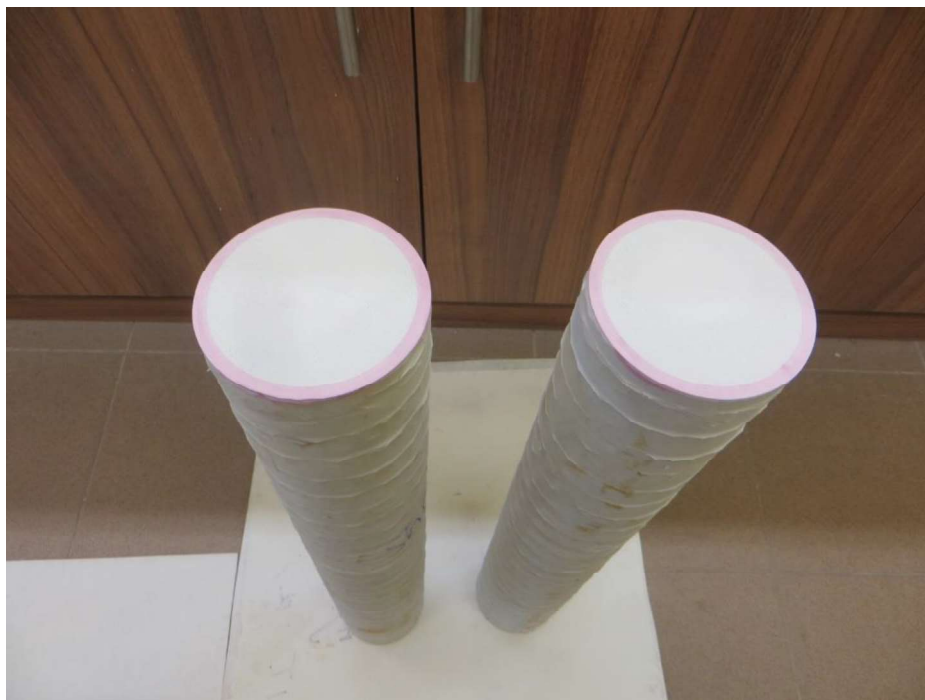
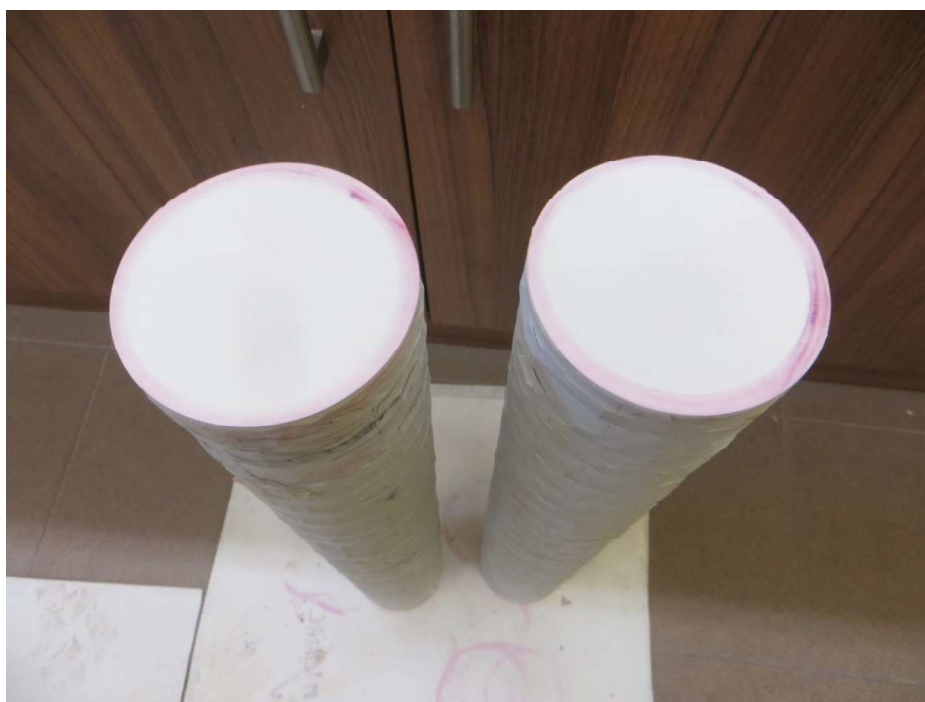
| Test result | : | <b><u>No cracks were observed after dye penetration test on insulator No. #4 - insulator passed.</u></b> |

**Photo 2:** View of sample after the dye penetration test
