## TEST REPORT 12591/D/24

| TEST OBJECT | Station post insulator | |
| TYPE SPECIFICATION | TR-288 | |
| TEST STANDARDS | ANSI C29.19-2020, ANSI C29.11-2020 | |

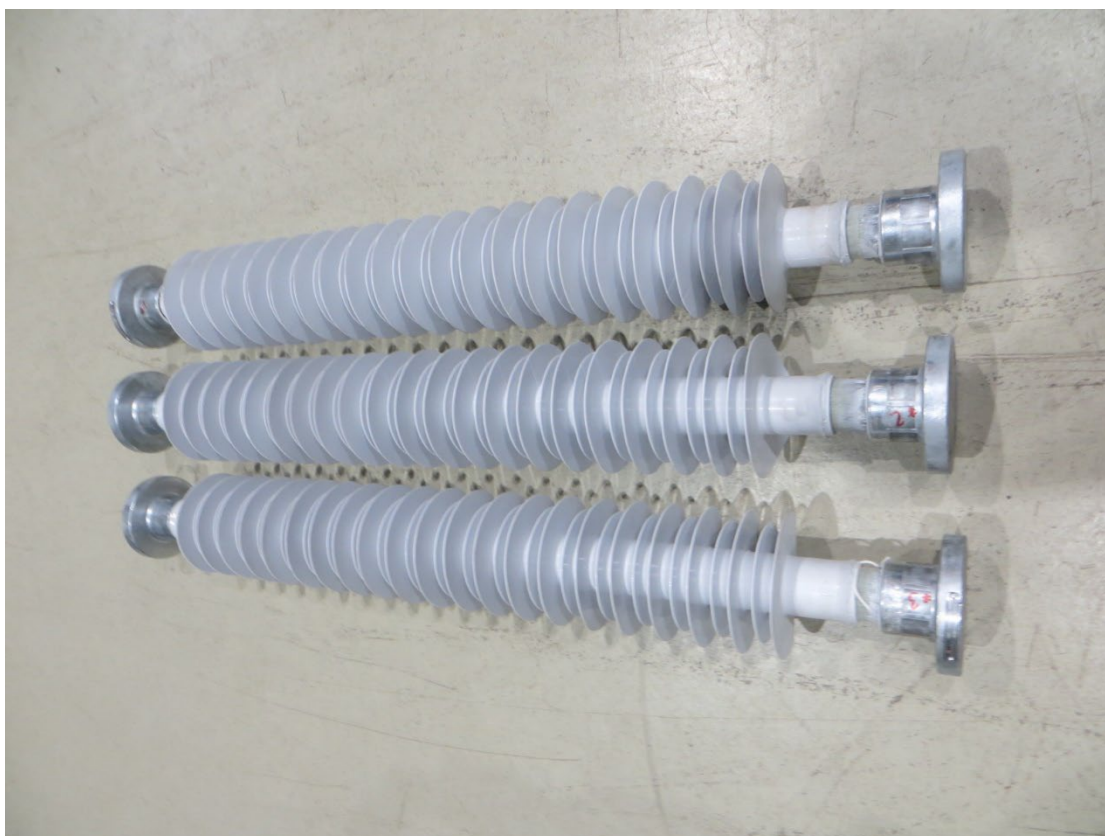
*Figure 16 Test samples after tensile load test*

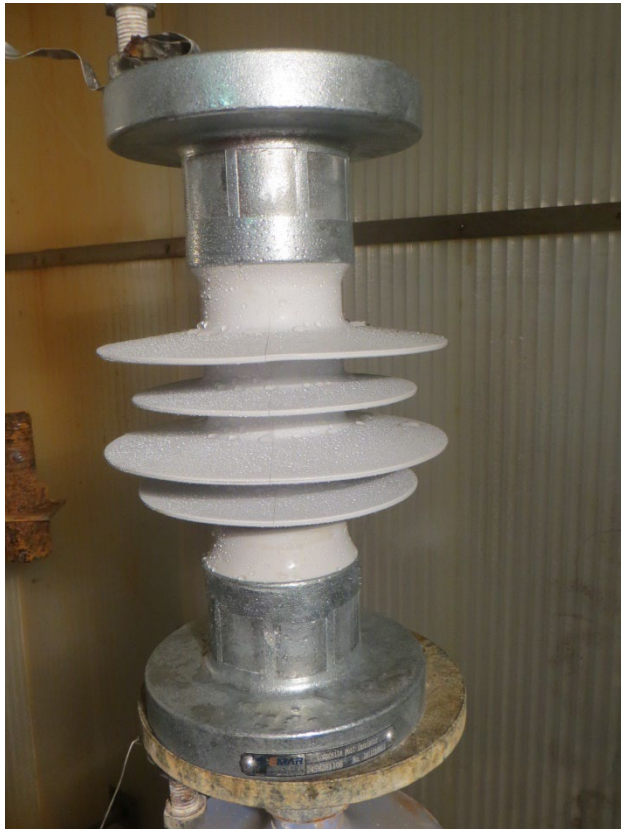
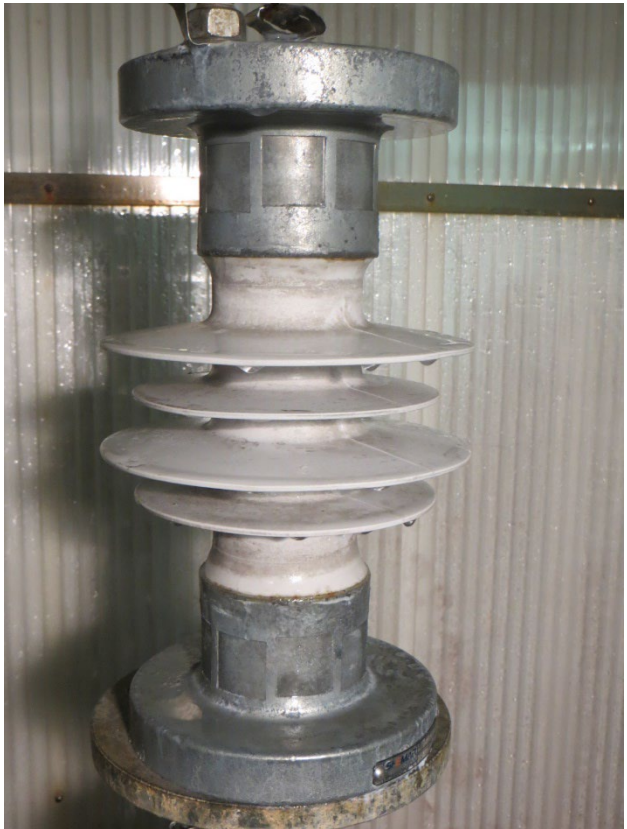
Figure 17 Test sample in vertical test position, before and after tracking end erosion test – 1000h salt fog test

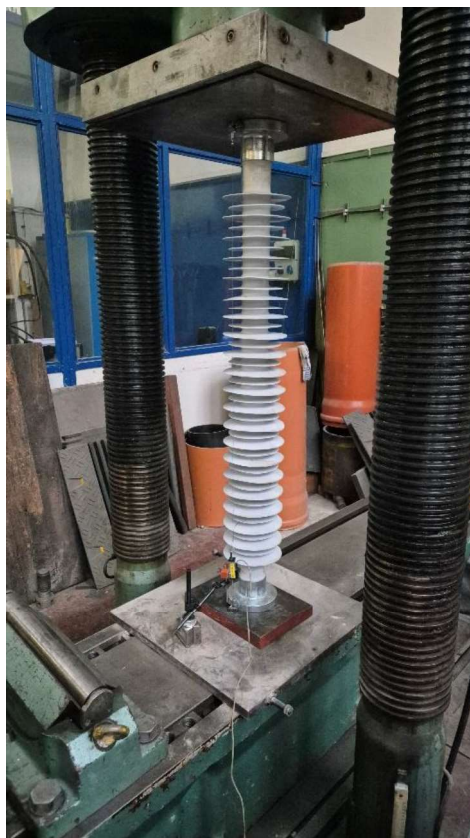
**Photo 1** – Characteristic arrangement of the compression test

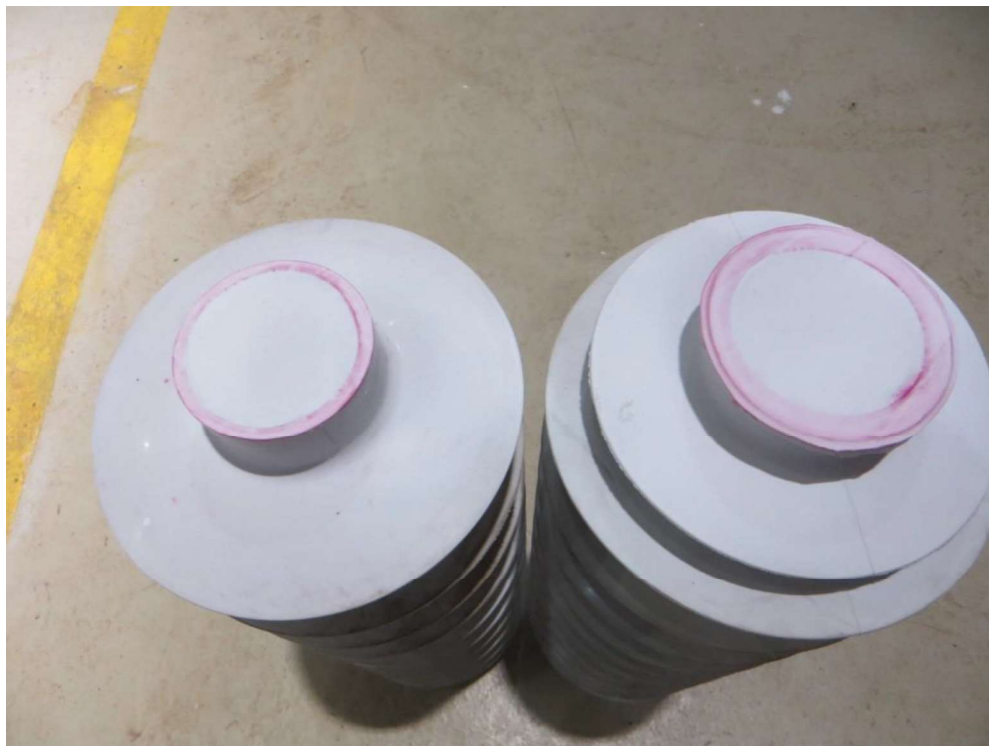
**Photo 2:** View of sample after the dye penetration test

| Test result | : | <b><u>No cracks were observed after dye penetration test on insulator No. #4 - insulator passed.</u></b> |

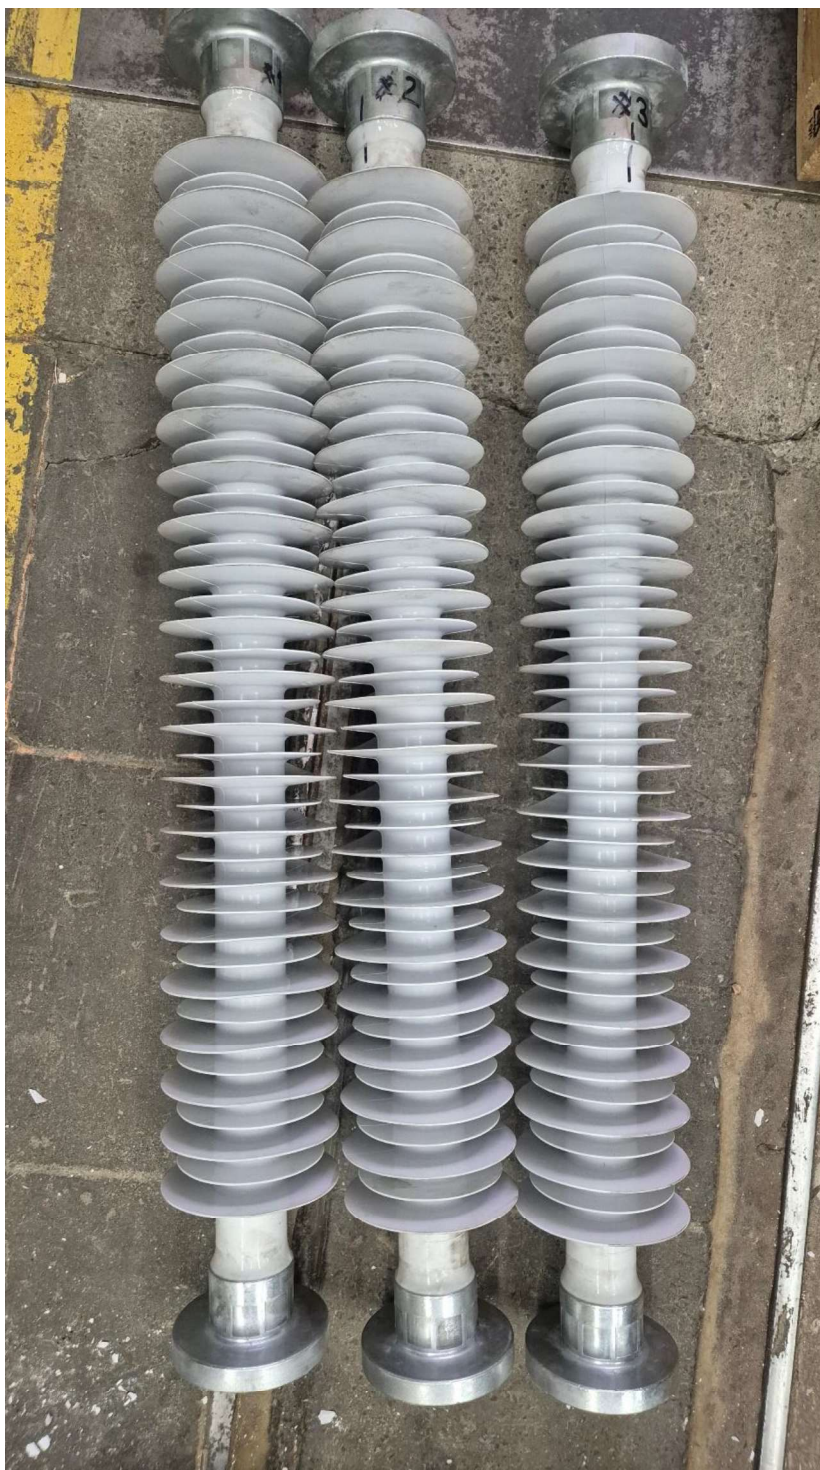
**Photo 4 – Samples after the torsional test****Uncertainty of measurement**

| Sample No. | Failing load [kNm] | Way of failure |
|---|---|---|
| 2 | 4,12 | Breakage of core inside of flange |
| 3 | 3,88 | Breakage of core inside of flange |
